DEPARTMENT OF TRANSPORTATION**DIVISION OF ENGINEERING SERVICES**

Office of Structural Materials

Contract #: 04-0120F4Cty: SF/ALA Rte: 80 PM: 13.2/13.9File #: 1.28**WELDING INSPECTION REPORT****Resident Engineer:** Casey, William**Address:** 333 Burma Road**City:** Oakland, CA 94607**Report No:** WIR-027824**Date Inspected:** 25-Jun-2012**Project Name:** SAS Superstructure**OSM Arrival Time:** 700**Prime Contractor:** American Bridge/Fluor Enterprises, a JV**OSM Departure Time:** 1930**Contractor:** American Bridge/Fluor Enterprises, a JV**Location:** Job Site**CWI Name:** As noted below**CWI Present:** Yes No**Inspected CWI report:** Yes No N/A**Rod Oven in Use:** Yes No N/A**Electrode to specification:** Yes No N/A**Weld Procedures Followed:** Yes No N/A**Qualified Welders:** Yes No N/A**Verified Joint Fit-up:** Yes No N/A**Approved Drawings:** Yes No N/A**Approved WPS:** Yes No N/A**Delayed / Cancelled:** Yes No N/A**Bridge No:** 34-0006**Component:** SAS OBG**Summary of Items Observed:**

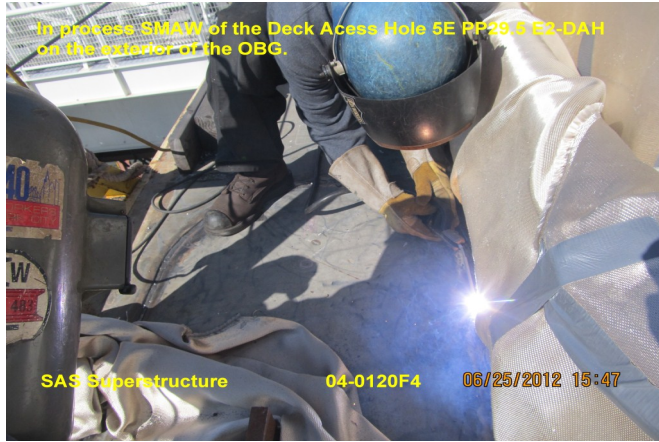
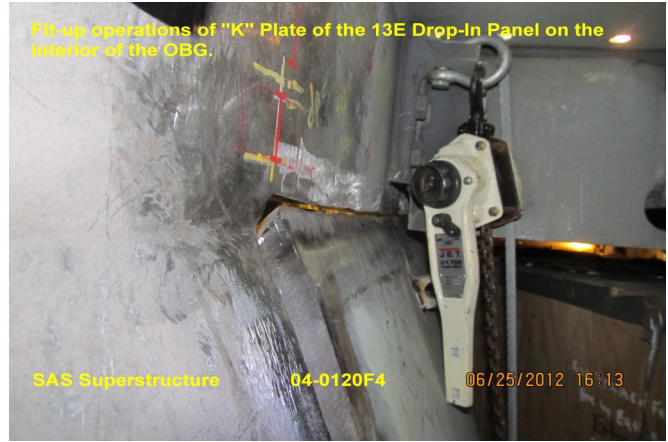
This QA Inspector made random observations of SMAW on the root joint of the Deck Access Hole (DAH) at 5E PP29.5 E2-DAH on the exterior of the OBG. ABF/JV qualified welder Todd Jackson #4639 was observed welding in the 1G flat position using 3.2mm" diameter E7018-H4R electrodes. This QA Inspector observed QC Inspector Steve Jensen verify prior to the start of welding operations, that the minimum preheat temperature as per the approved WPS was established; and afterwards verified that the welding parameters (Amps) were in accordance with ABF-WPS-D1.5-1010-Revision 1. The welder was observed grinding and blending the start/stop edges of the work utilizing a small disc grinder and compressed air in between passes. This QA Inspector noted that the 3.2mm electrodes were stored in electrically heated, thermostatically controlled oven after removal from the sealed containers. The exposure limits of the electrodes appeared to comply with the minimum storage oven temperature of 120 degrees Celsius as per the contract documents. The welding parameters and surface temperatures were verified by the QC inspector's utilizing a Fluke 337 clamp meter to measure the electrical welding parameters and Tempilstik Heat Indicators for verifying the preheat and inter-pass temperatures. At the time of the observations no issues were noted by the QA. On subsequent observations throughout the shift to monitor quality, it was noted that the work was in progress and appeared to be in general conformance with the contract documents.

This QA Inspector randomly observed ABF personnel using the 4100 Ringer Crane, lift the corner drop-in panel from a storage barge, and place it on the OBG deck. The workers used bolts and pins to temporarily secure it in place. It was noted that the welding of the temporary attachment alignment fit-up gear commenced on this date. QC Salvador Merino was observed monitoring the welding and conducted fit-up operations. This QA Inspector made subsequent observations throughout the shift to monitor quality and noted that the work at this location and appeared to be in general conformance with the contract documents.

This QA Inspector randomly observed the “K” plate on the interior of the OBG. ABF/JV qualified welder Richard Garcia #5892 was observed welding temporary attachments to the plate for alignment. The weld surface and surrounding area was brought to temperature by the use of a gas torch and the preheat temperature was confirmed by QC prior to welding. QC Salvador Merino was noted monitoring the welding parameters during welding. The alignment and fit-up operations at this location was observed to be in progress and appeared to be in general conformance with the contract documents.

This QA Inspector randomly observed the repair welding operations performed by ABF/JV qualified welder Steven Davis (ID 7889) at the locations listed below. The welder was observed using the Carbon Arc Gouging (CAG) process to excavate the sites. Upon removal of the discontinuities, QC Inspector Salvador Merino performed Magnetic Particle Testing (MT) to ensure soundness of the metal and observed no relevant indications and recorded the dimensions of the excavations which are listed below. The welder was observed depositing metal by utilizing the SMAW process in the 3G vertical and 2G horizontal positions employing 3.2mm E7018-H4R electrodes drawing amperage of 127 as pertaining to ABF-WPS-D1.5-1000-Repair. This QA Inspector verified that the electrodes were obtained from a baking oven at the correct temperature and within acceptable exposure limits. The welder was observed cleaning the start/stop edges of the work utilizing small disc grinders and compressed air and restored the base metal to the original surface and ground smooth, and the welds to their specific profiles. The repairs were completed on this date and appeared to be in general conformance with the contract specifications.
